UNDERWATER BRIDGE INSPECTION REPORT

STRUCTURE NO. 93280
CR NO. 119
OVER THE
EAST BRANCH OF THE RAT ROOT RIVER
DISTRICT 1 - KOOCHICHING COUNTY

PREPARED FOR THE
MINNESOTA DEPARTMENT OF TRANSPORTATION
BY
COLLINS ENGINEERS, INC.
JOB NO. 3512(CEI 15)

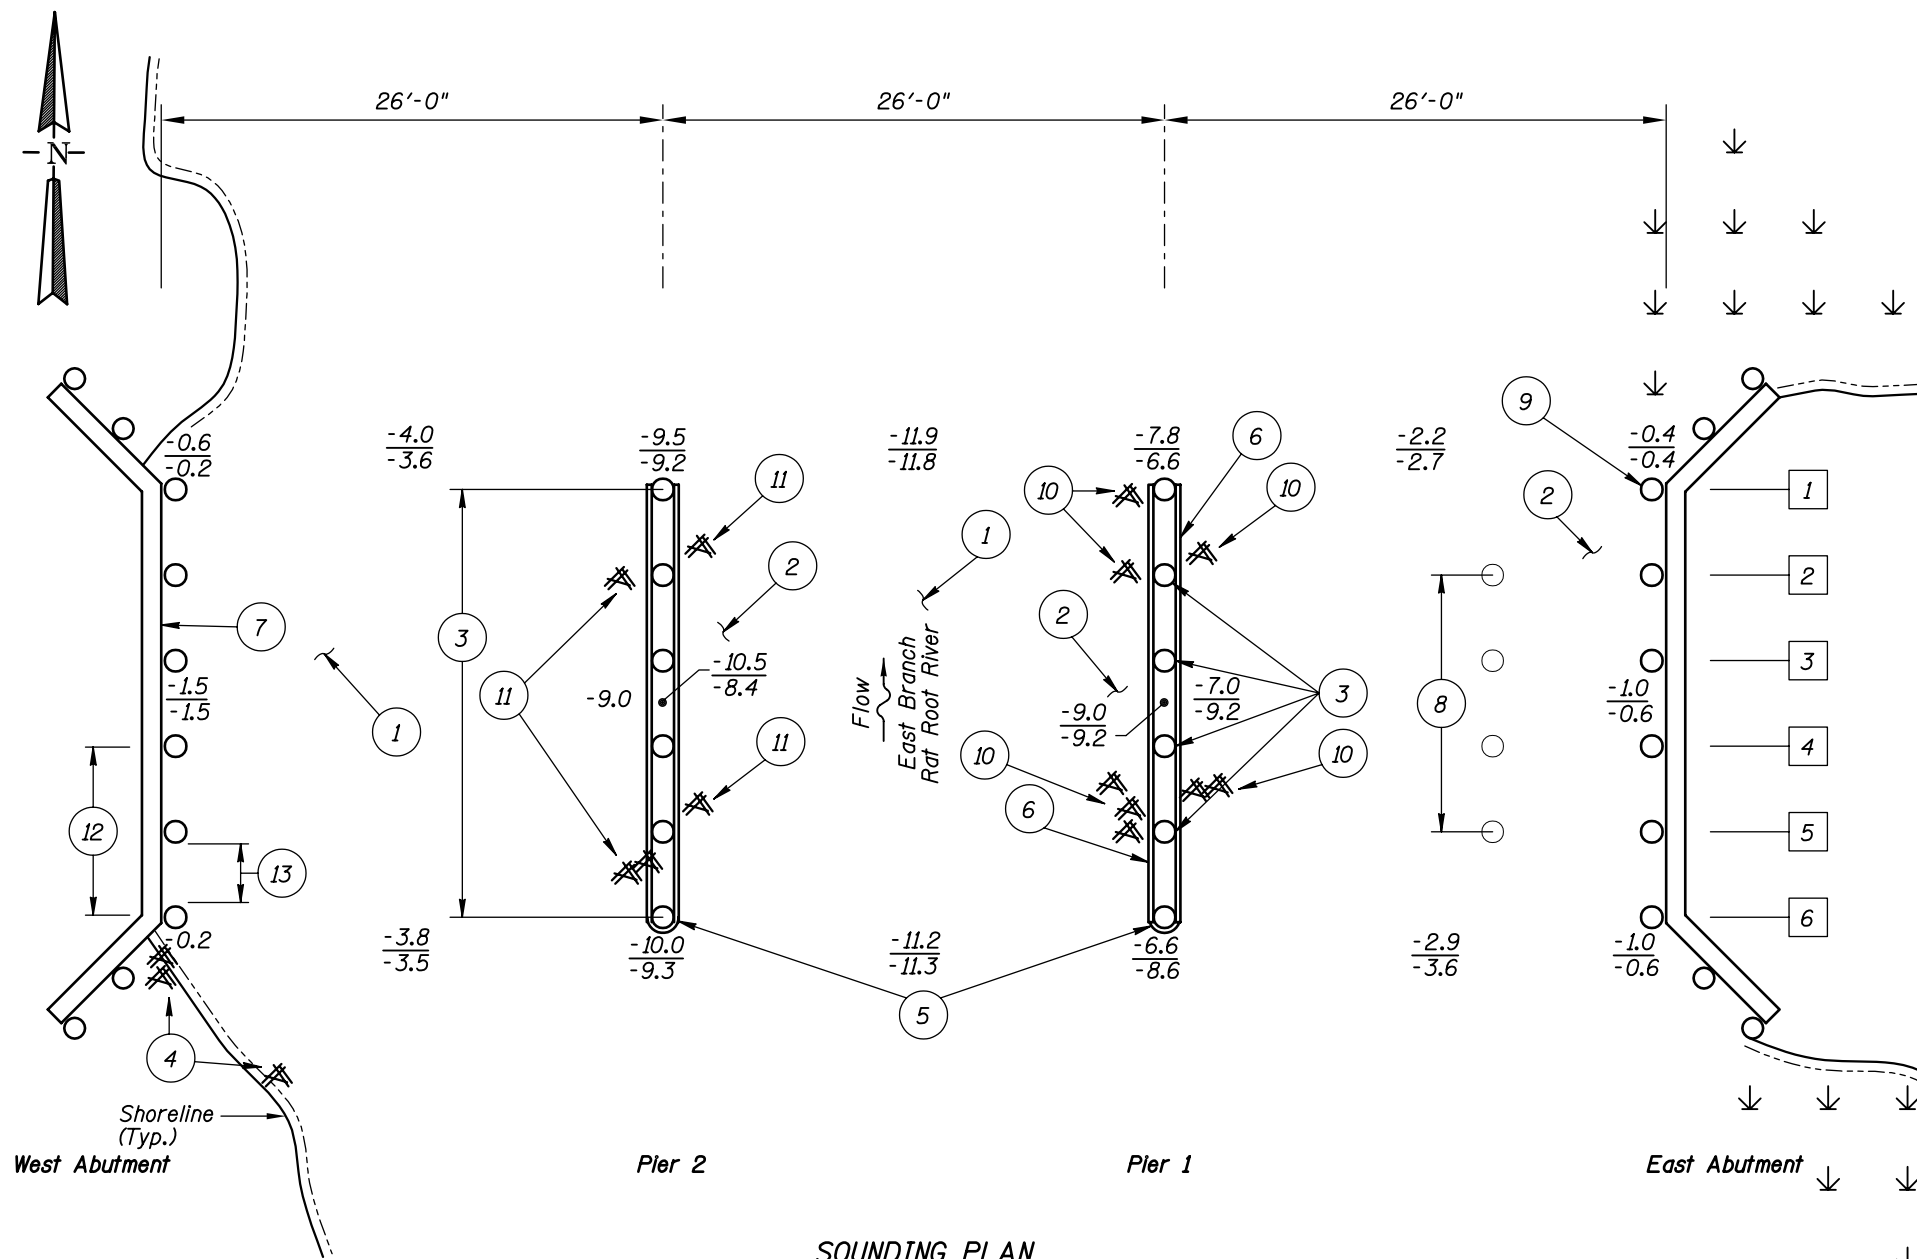
INSPECTION AND SOUNDING PLAN

- The channel bottom material consisted of a soft, silty, sandy clay with 6 inches to 1 foot of probe rod penetration.
- The channel bottom material around Piers 1 and 2 and the East Abutment consisted of 6 inch to 12 inch diameter riprap.

- Piles exhibit random checking from the waterline to 3 feet below the waterline with up to 1/4 inch maximum width.
- Light accumulation of timber debris along shoreline.

- Curved steel ice-breaker plates from just below the pile caps down to approximately 1 foot below the waterline were attached to the south face of the outside piles.

- Diagonal braces split and fasteners pulled through at Piles 1, 2, and 3 on the east side of Pier 2 and Piles 5 and 6 on the west side of Pier 2.
- Pile cap slightly rotated back with 75 percent typical bearing on the piles.

- Row of old piles cut of at 2 inches above the channel bottom.
- A large vertical split approximately 2 feet high by 1/4 inch wide, with 1 inch penetration located at top of pile.

- Light accumulation of timber debris at Piles 1, 2, and 5, up to 6 inches diameter pieces, typically extending 3 feet above channel bottom.
- Light accumulation of timber debris at Piles 2 and 5, up to 6 inches diameter pieces, typically extending 3 feet above channel bottom.

- Escaping fill was observed at 1 inch gap in horizontal planking, 4 feet above mudline, with 3 inches maximum penetration.
- Escaping fill was observed at 1 inch gap in horizontal planking, 3 feet above mudline, with 3 inches maximum penetration.

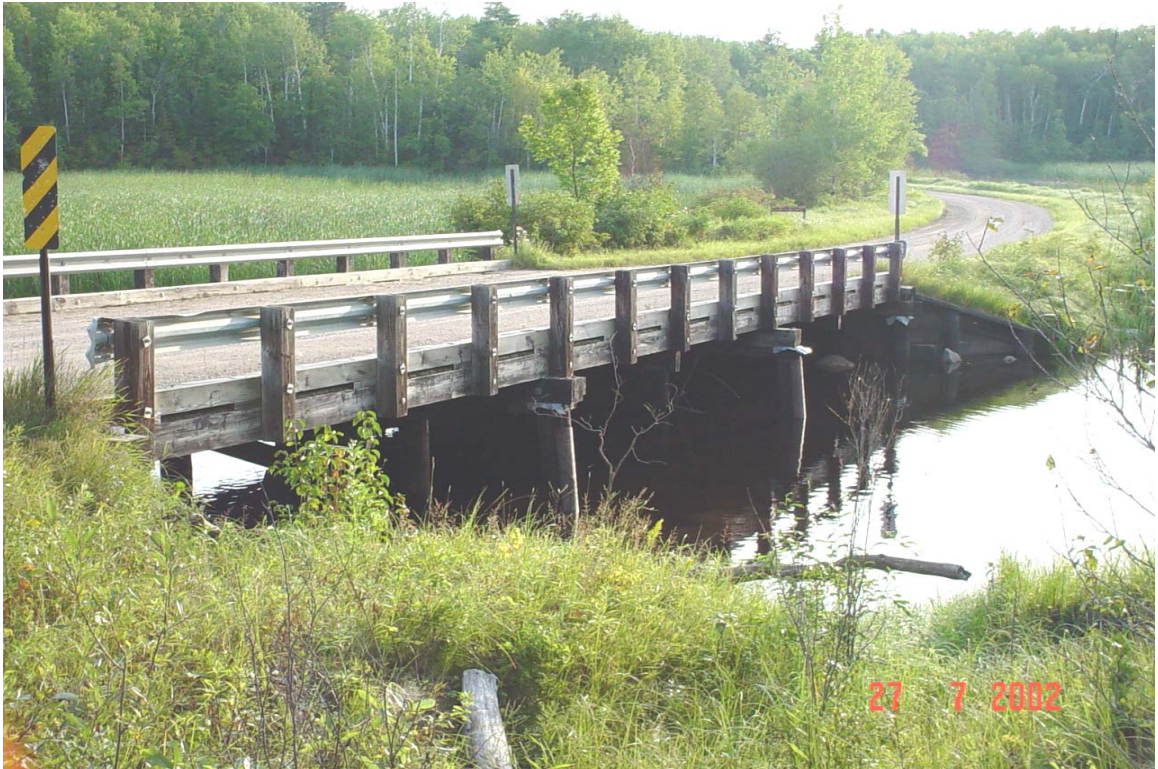
Photograph 1. Overall View of the Structure, Looking Northeast.

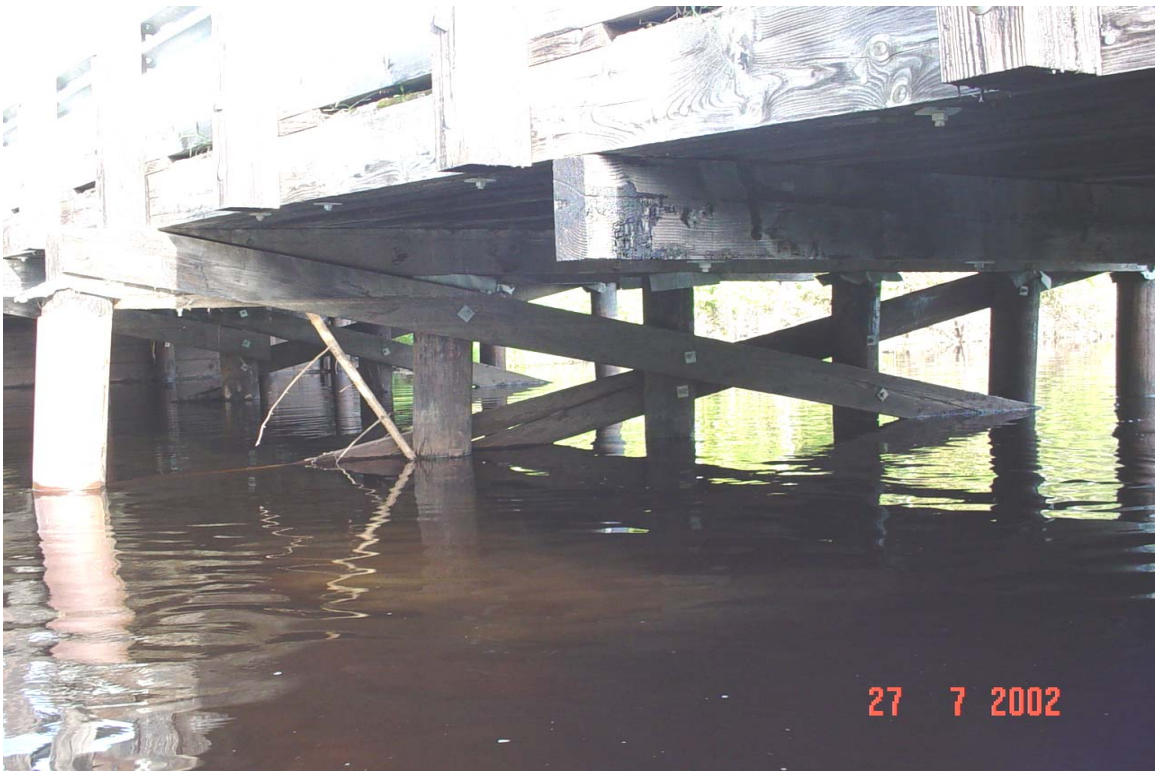
Photograph 2. View of Pier 1, Looking Northwest.

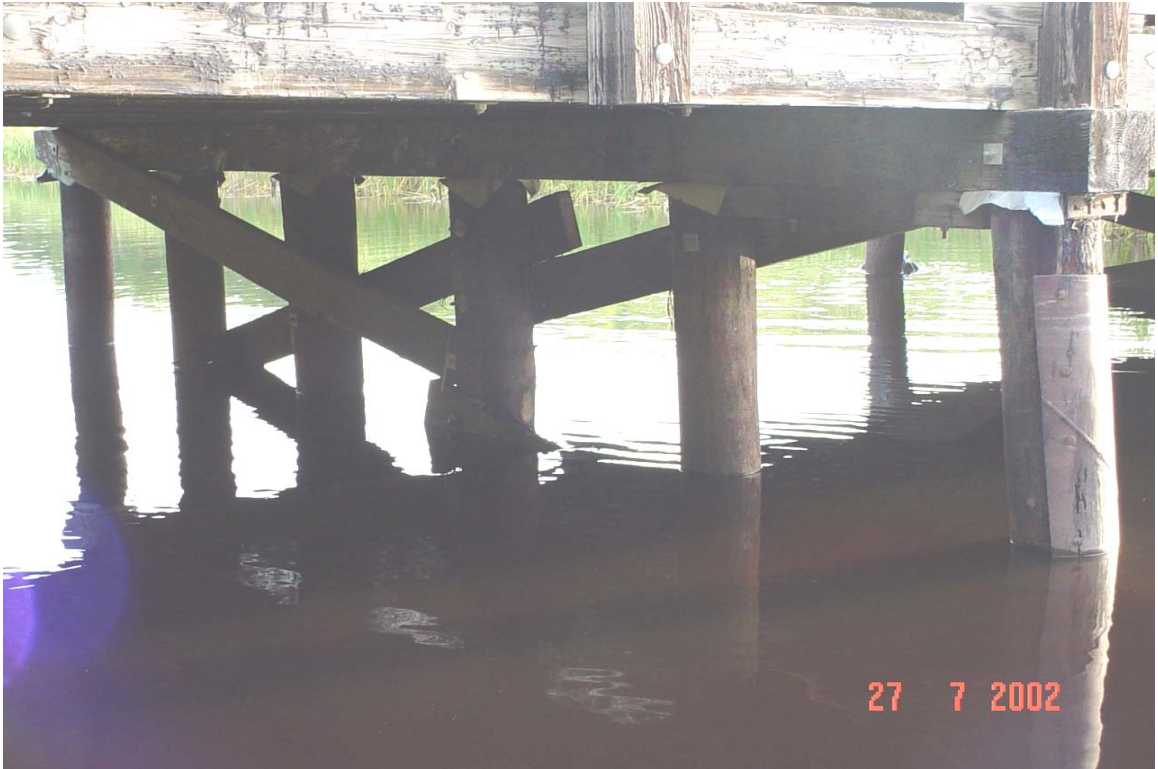
Photograph 3. View of Pier 2, Looking Northeast.

- (A) The diagonal timber cross brace, that is split through the fasteners at Pier 2, should be replaced during routine maintenance.
- (B) Reinspect the submerged substructure units at the normal maximum recommended (NBIS) interval of five (5) years.

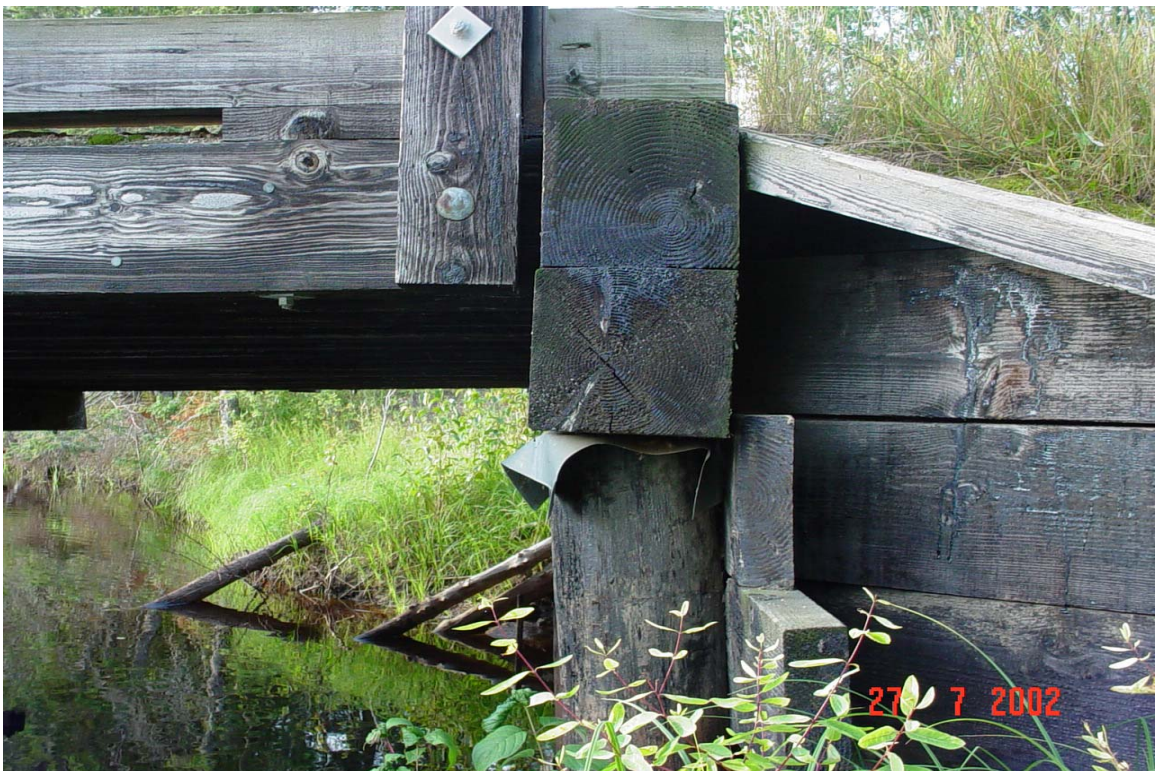
Photograph 4. View of Top of West Abutment, Looking South.

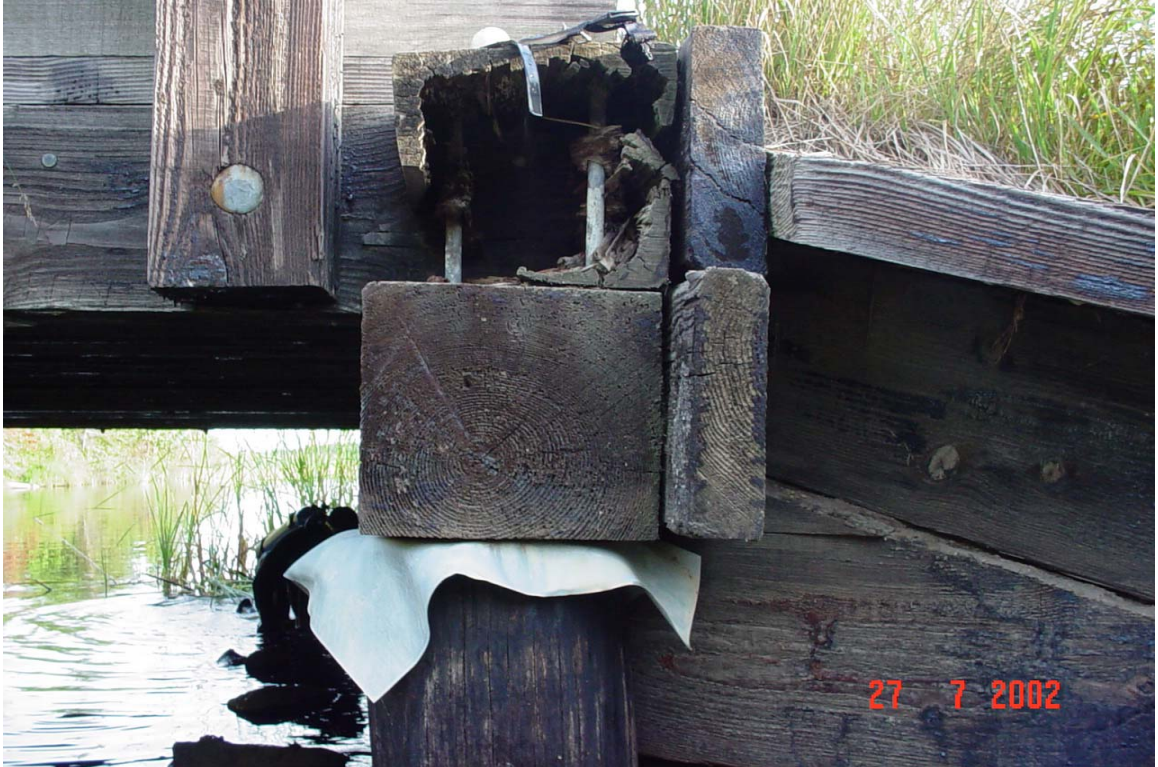
Photograph 5. View of Top of East Abutment, Looking North.

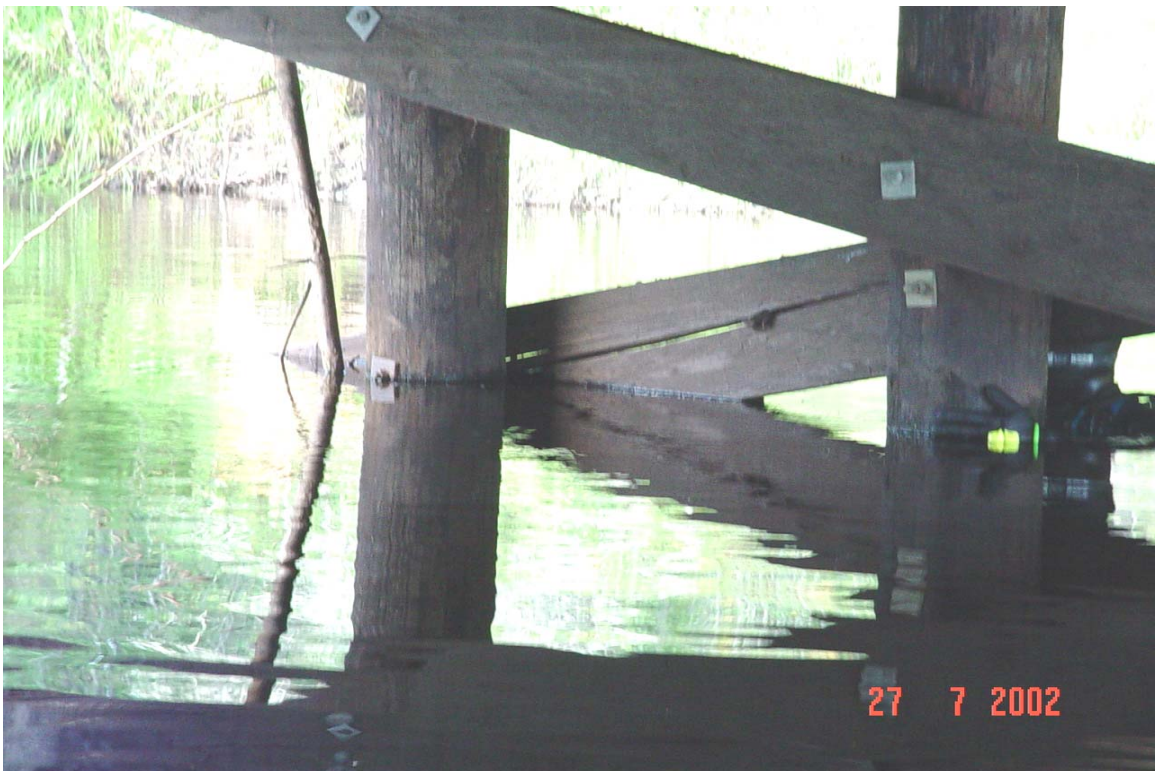
Photograph 6. View of Split in Cross Bracing at Pier 1, Looking Southwest.

The timber cross bracing member that exhibited cracking at Pier 1 should be replaced during routine maintenance to reestablish lateral stability to the pier.

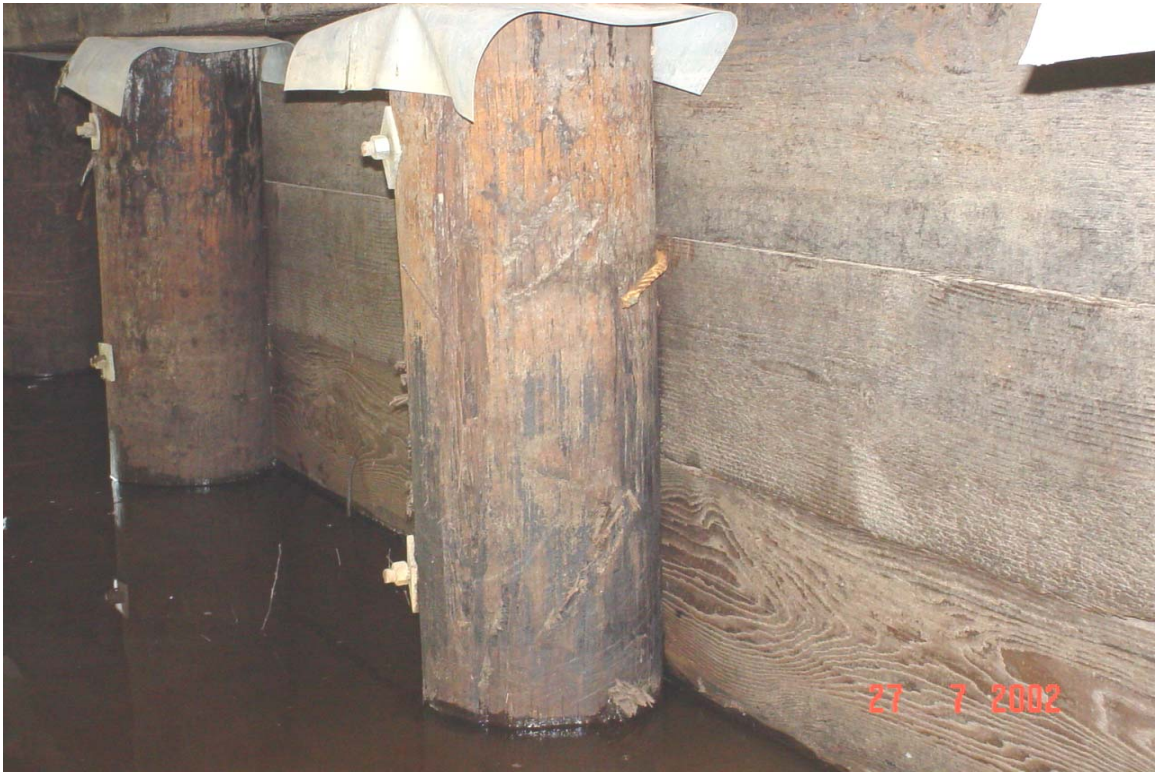
Photograph 7. View of Typical Checking of Piling at East Abutment, Looking Northeast.
